CLARENCE J. BROWN RESERVOIR  
GREATER MIAMI RIVER BASIN  
OHIO

EMBANKMENT CRITERIA AND  
PERFORMANCE REPORT

PREPARED BY  
U.S. ARMY ENGINEER DISTRICT, LOUISVILLE  
CORPS OF ENGINEERS

SEPTEMBER 1982

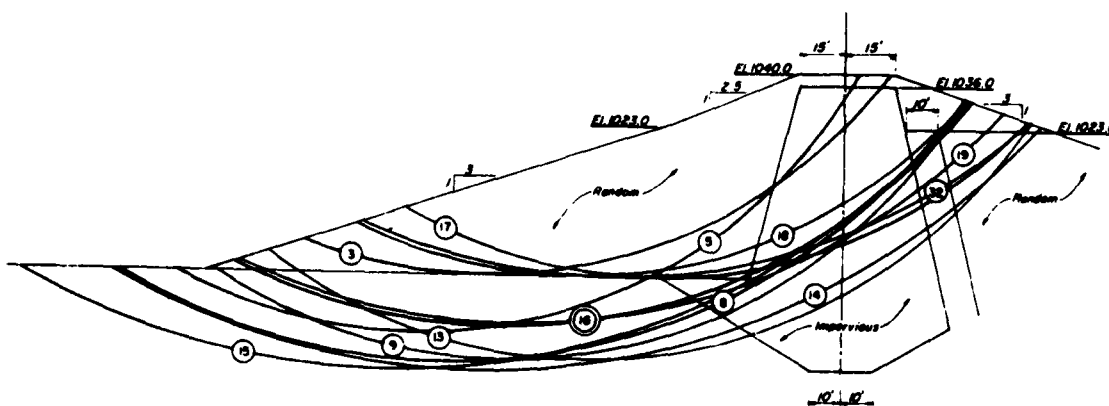
Summary of safety factors determined by W.E.S. Computer Program		
POST CONSTRUCTION CONDITION		
CIRCLE	SAFETY FACTORS	
	COMPUTED	REQUIRED
3	2.071	1.300
5	2.168	"
8	2.019	"
9	2.020	"
13	2.483	"
14	2.261	"
15	2.001	"
16	1.846	"
17	2.617	"
18	2.104	"
19	1.947	"
20	2.426	"

Safety factor  $\frac{\Sigma \text{SR} + \Sigma C}{\Sigma W} = \frac{494}{272} = 1.812$

W.E.S. computer safety factor = 1.846

**NOTE:**  
The difference in safety factors between analyses performed by the Waterways Experiment Station computer program and graphical analyses performed in the Fort Worth District is believed to be the result of small errors accumulated in the manual computations.

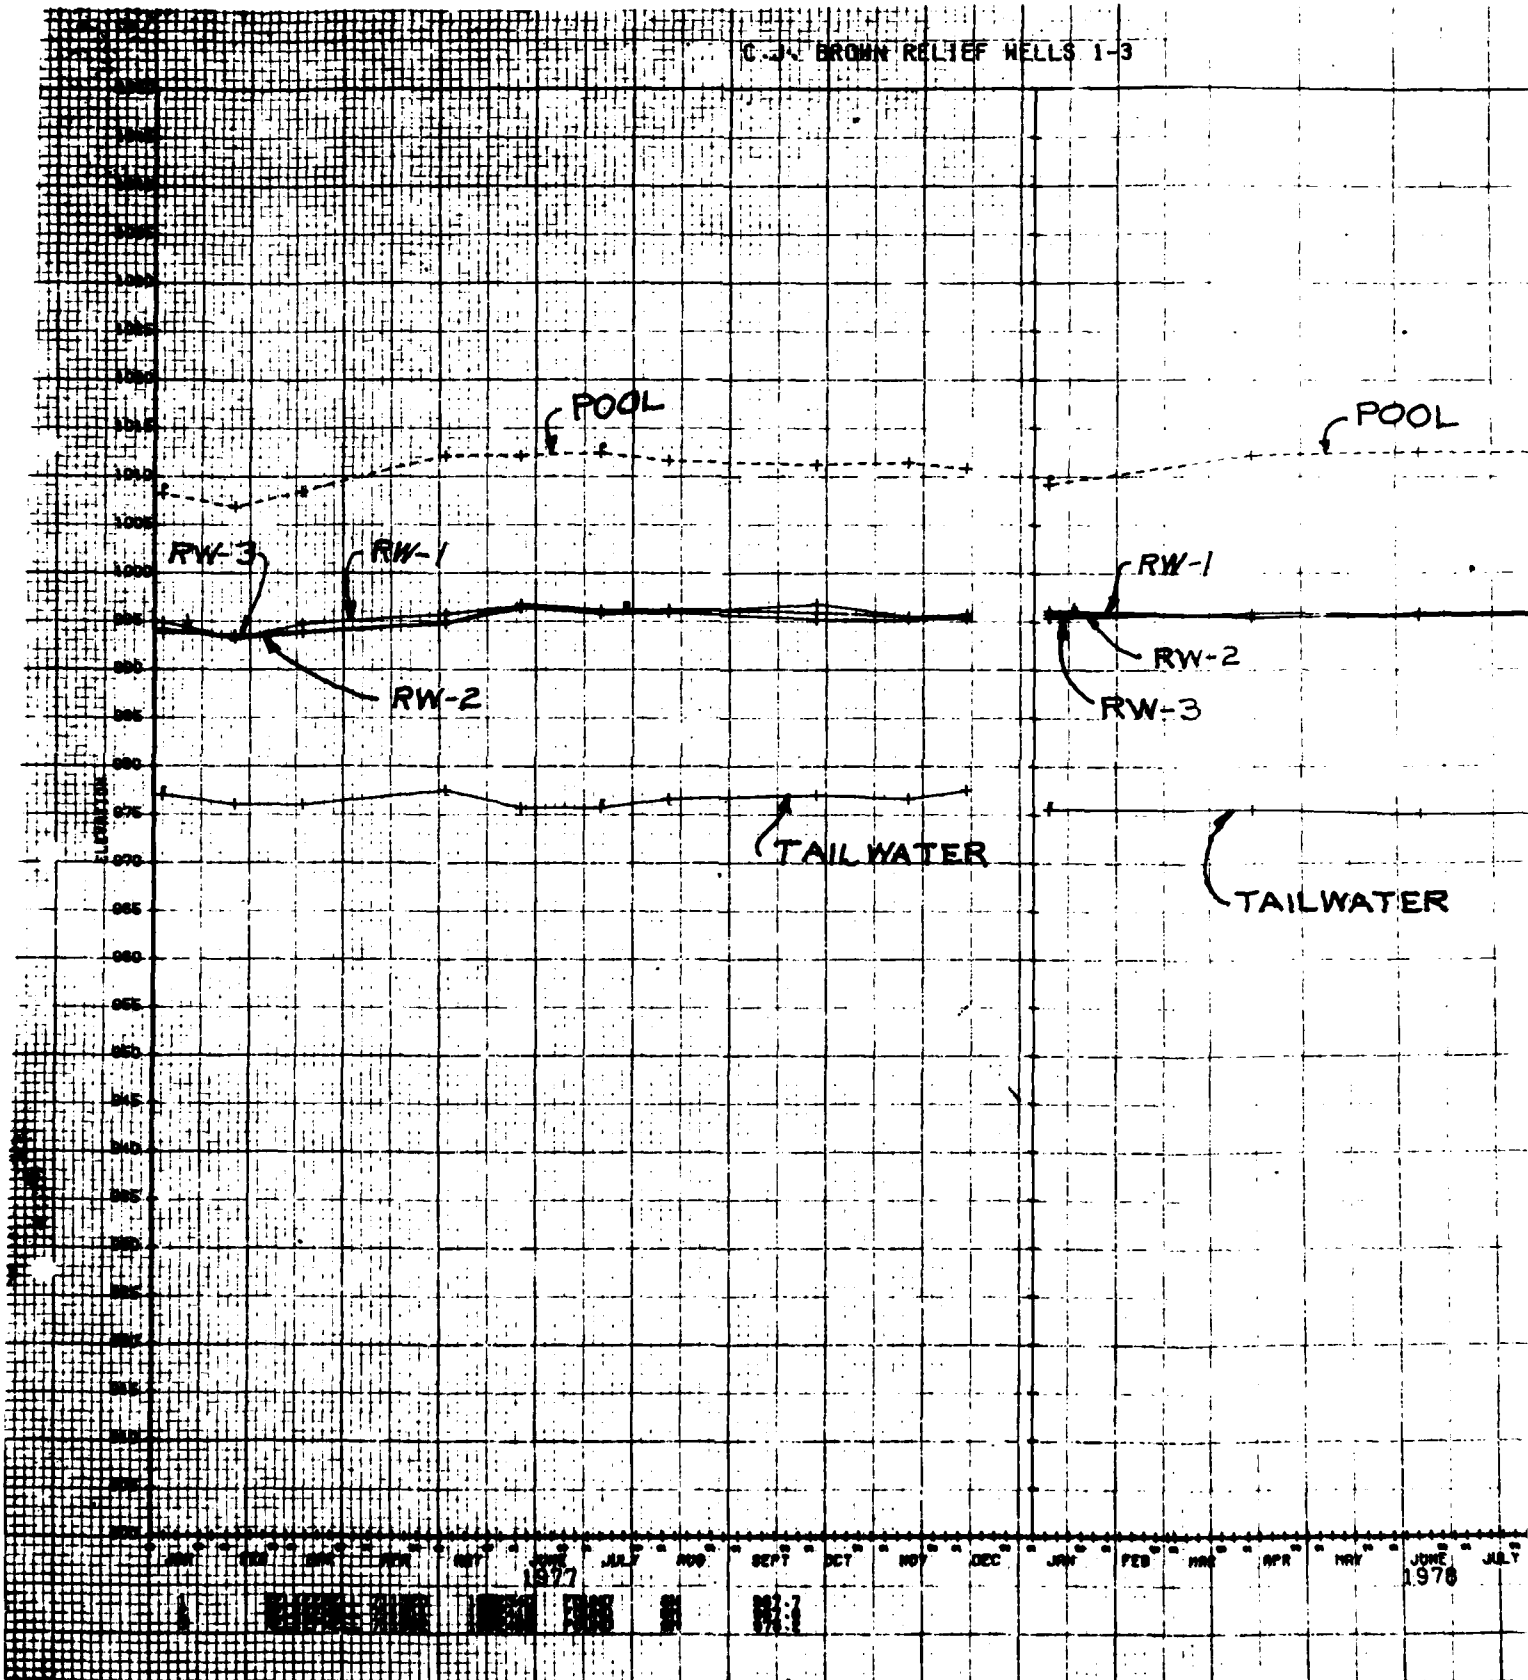
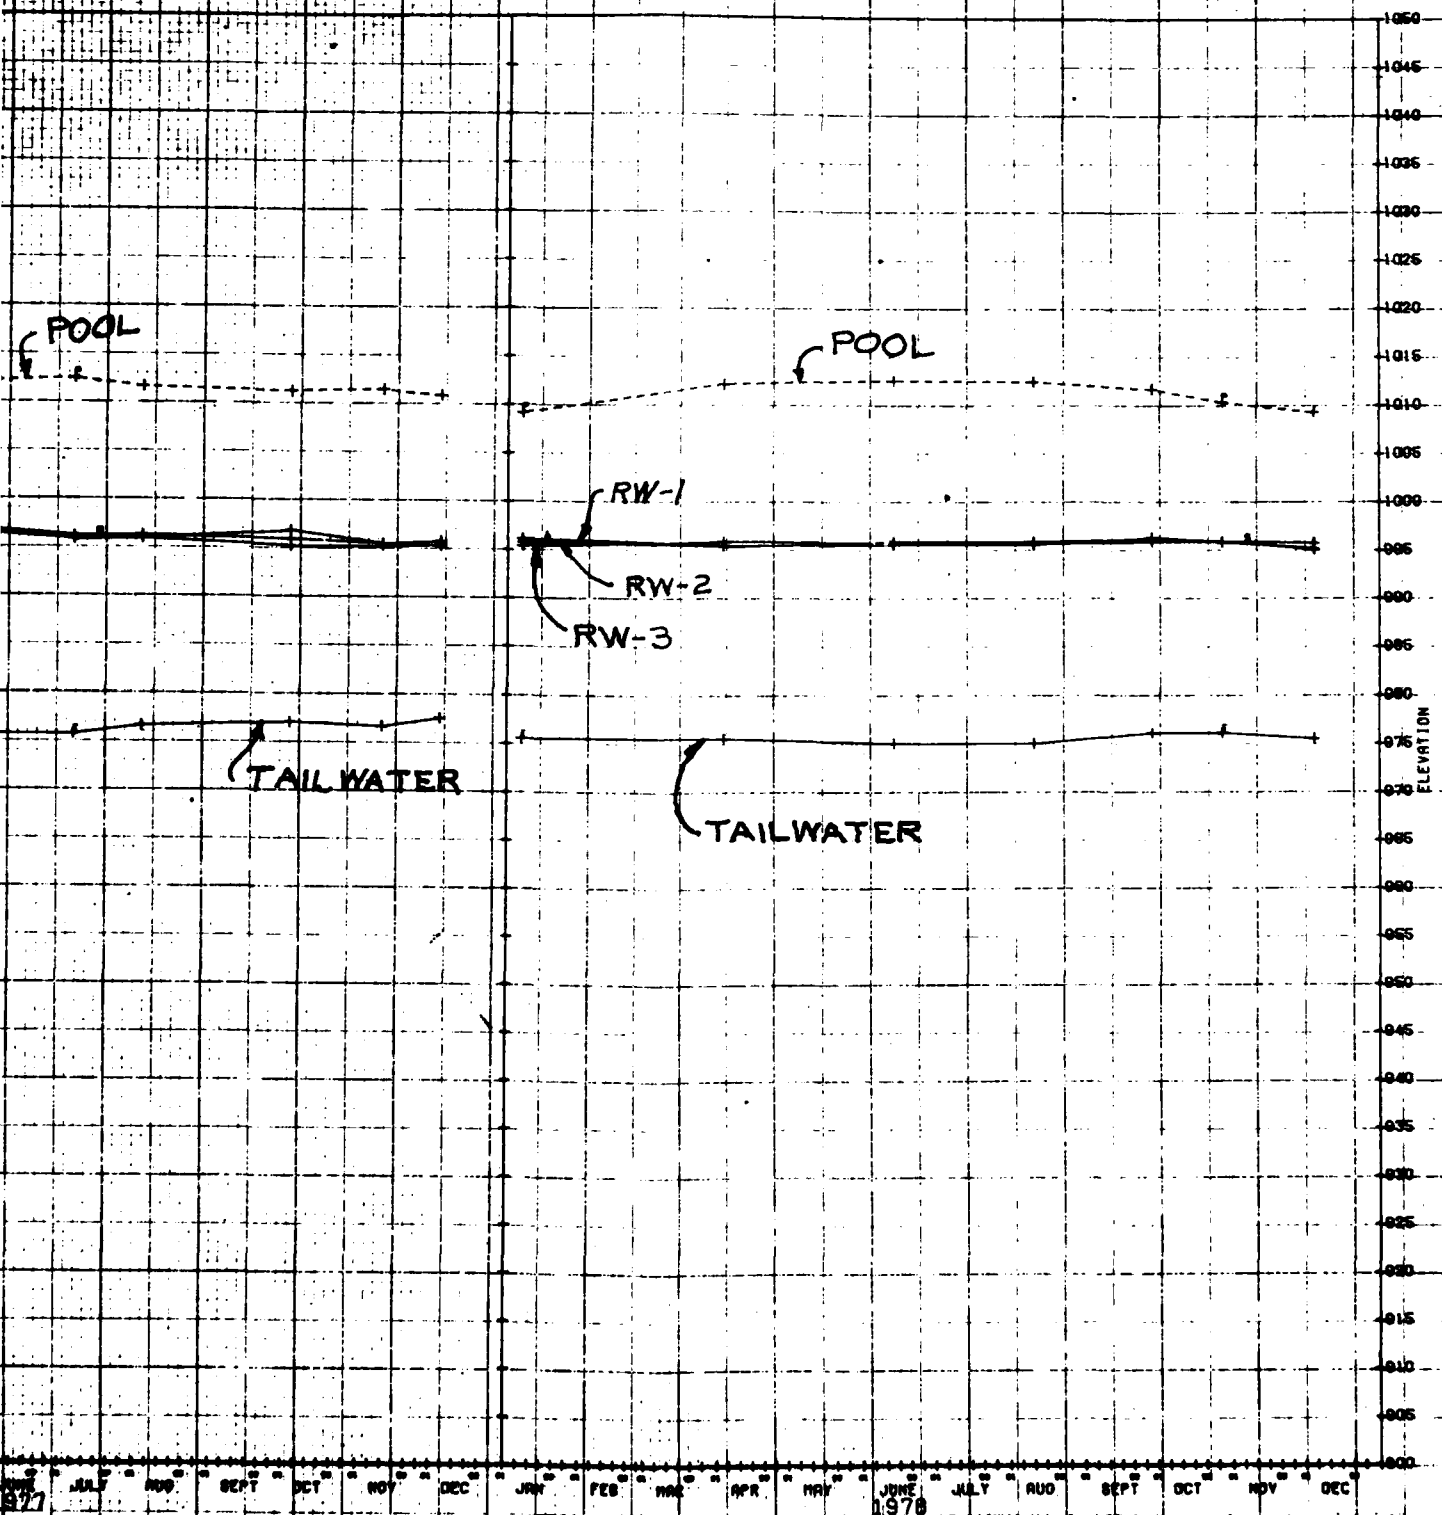
# C. J. BROWN RELIEF WELLS 1-3

(3) Relief Wells - The three relief wells located along the downstream toe of the dam from Station 53+25 to 54+75 react with the reservoir pool. No significant flood storage has occurred to date, therefore, the relief wells have not experienced discharge conditions. The plots of the relief wells are presented on Plate 26.
